# Intel® Xeon™ Processor

## Specification Update

Document Number: 249678-037

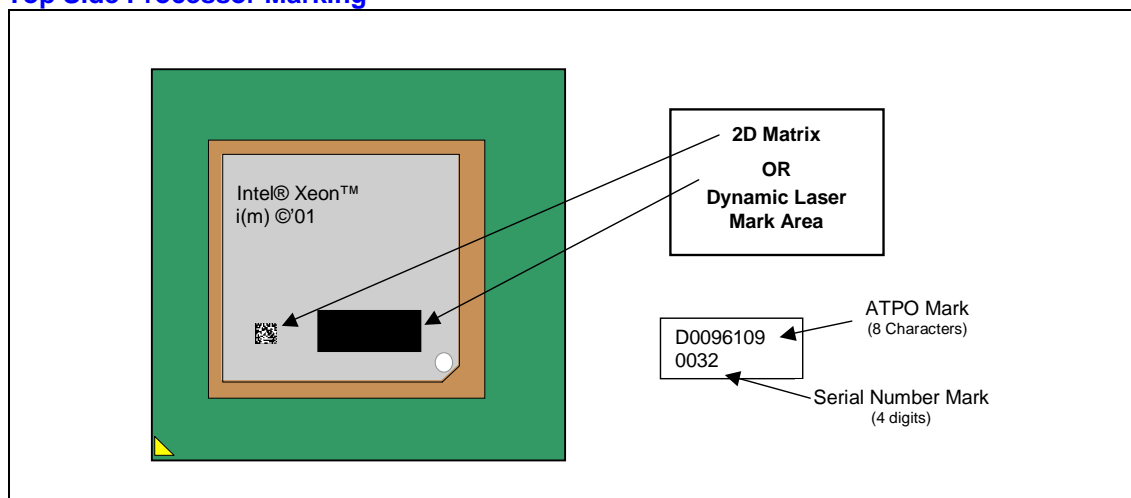
**Figure 1. Top Side Processor Marking**

## Intel® Xeon™ Processor Markings, 256-KB Cache (603-pin interposer INT-mPGA package)

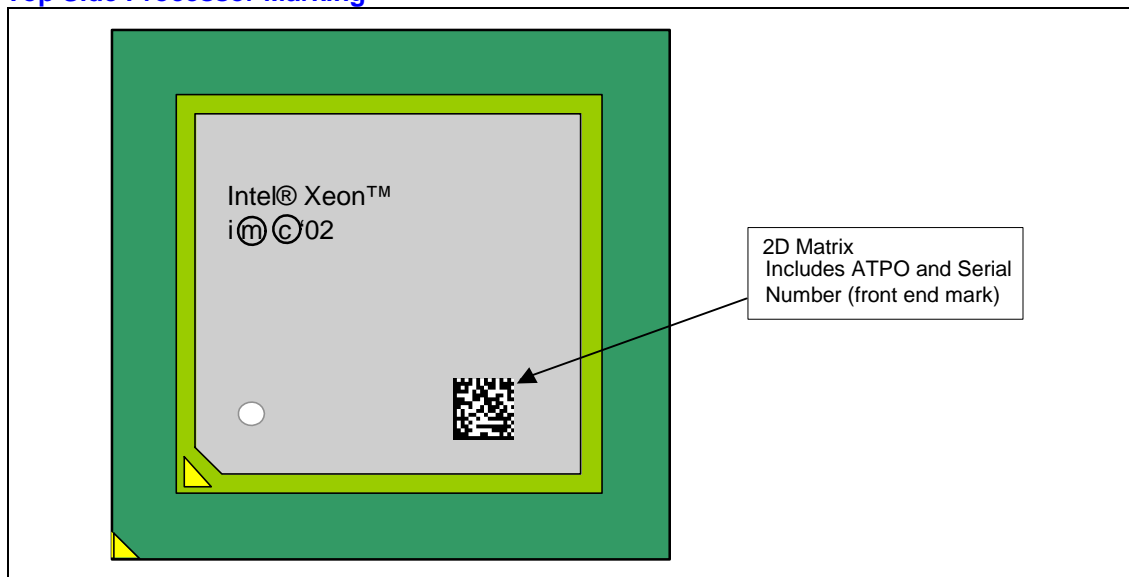
Figure 3. Top Side Processor Marking

## Intel® Xeon™ Processor , 512-KB Cache, 400 and 533 MHz FSB Markings, (603-pin interposer INT-mPGA package and 604-pin Fc-mPGA2 Package)

| Version | Description | Date |
|---|--|---|
| -010 | Added Documentation Changes P7-P11.<br>Added Errata P38-P44.<br>Added new processor with Processor Signature=0F24h B0 Step.<br>Added new Sspec processors to Processor ID and DP Matrix tables.<br>Added new package markings(Figs 3,4) for 512KB Cache processor. | January 2002 |
